## SERVICE BULLETIN No: 04/14052009

### Mandatory change of Cable stopper for front leg

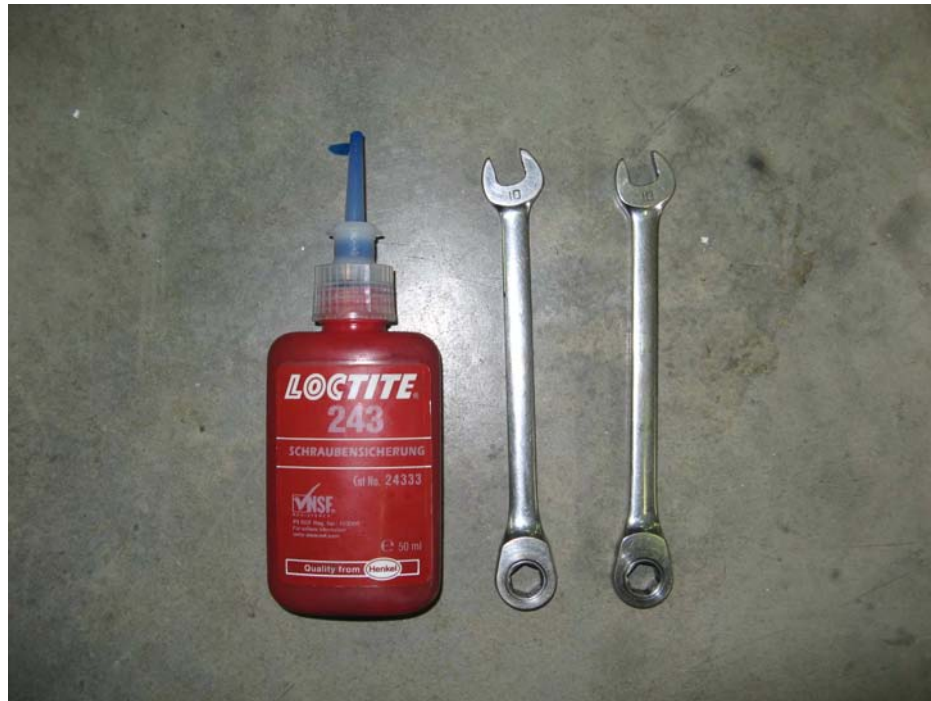
Picture 2-1 / Tools for change of Cable stopper/

Tools needed: 2 x 10 mm open ended spanners, thread glue LOCTITE 243 /Picture 2-1/
